**US Army Corps
of Engineers
Baltimore District**

**NATIONAL HISTORIC CONTEXT FOR
DEPARTMENT OF DEFENSE INSTALLATIONS, 1790 - 1940**

Volume II of IV

FINAL REPORT

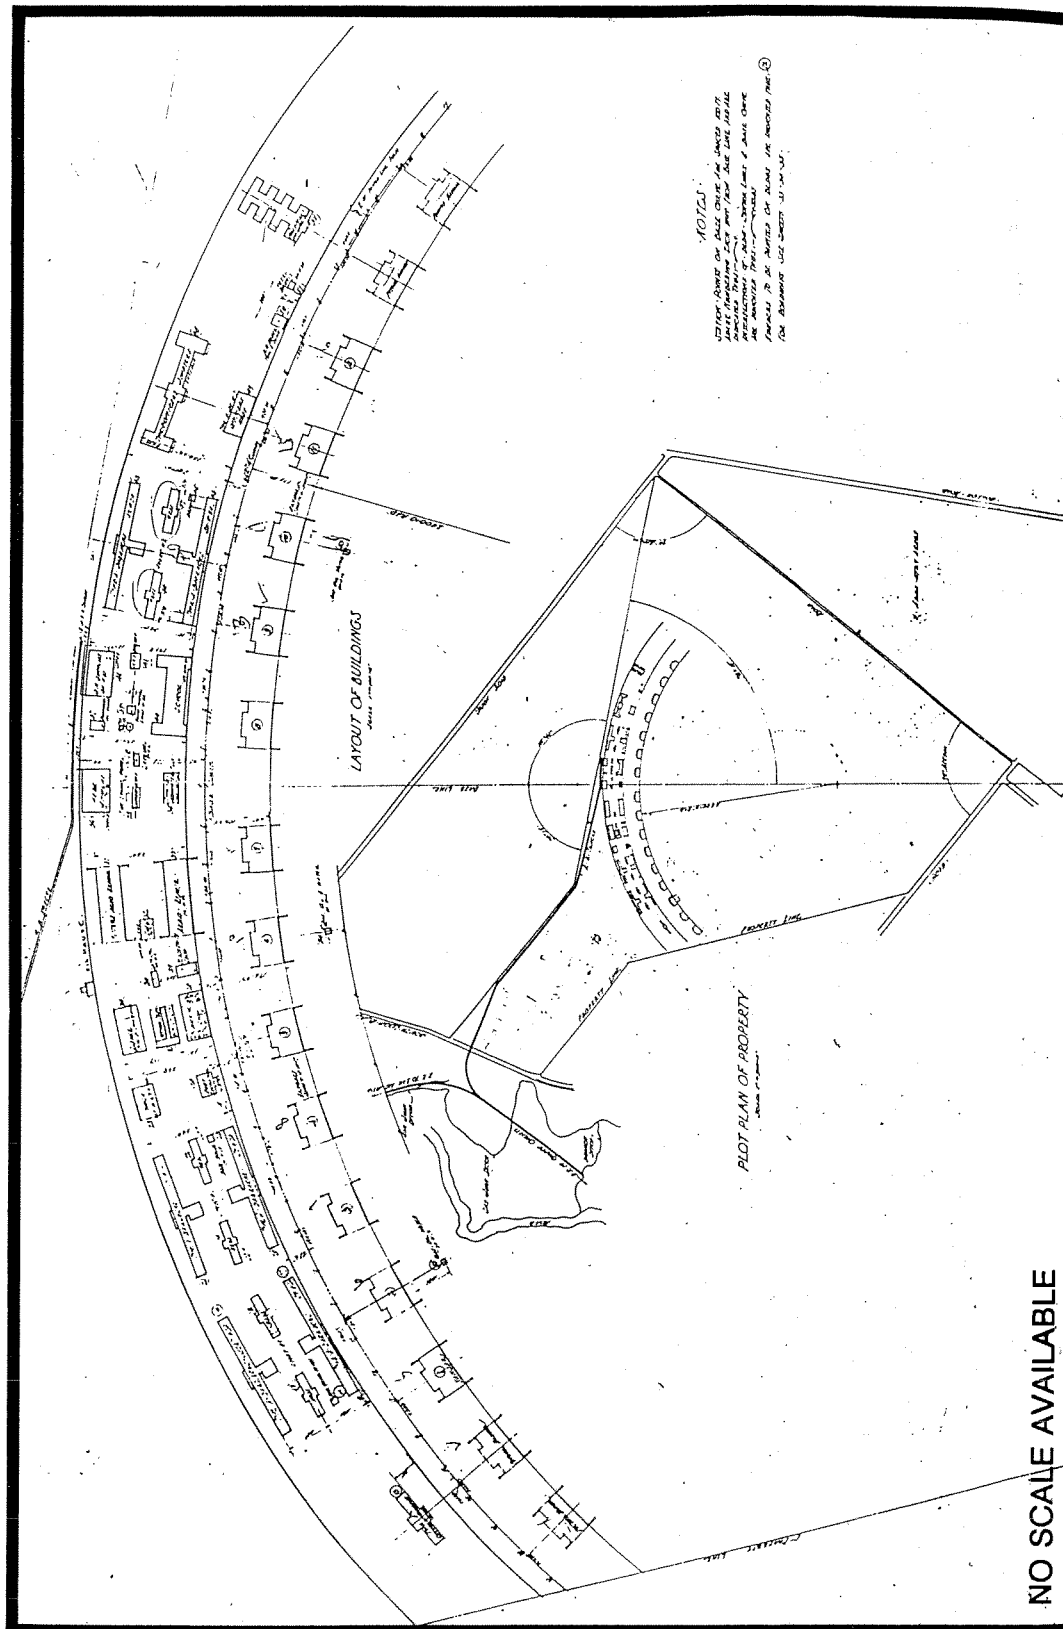
Figure III-158. Kelly Field #5 Plot Plan, 1917, Albert Kahn, Architect (From MSS files, Civil Engineering, Brooks AFB, San Antonio, Texas)

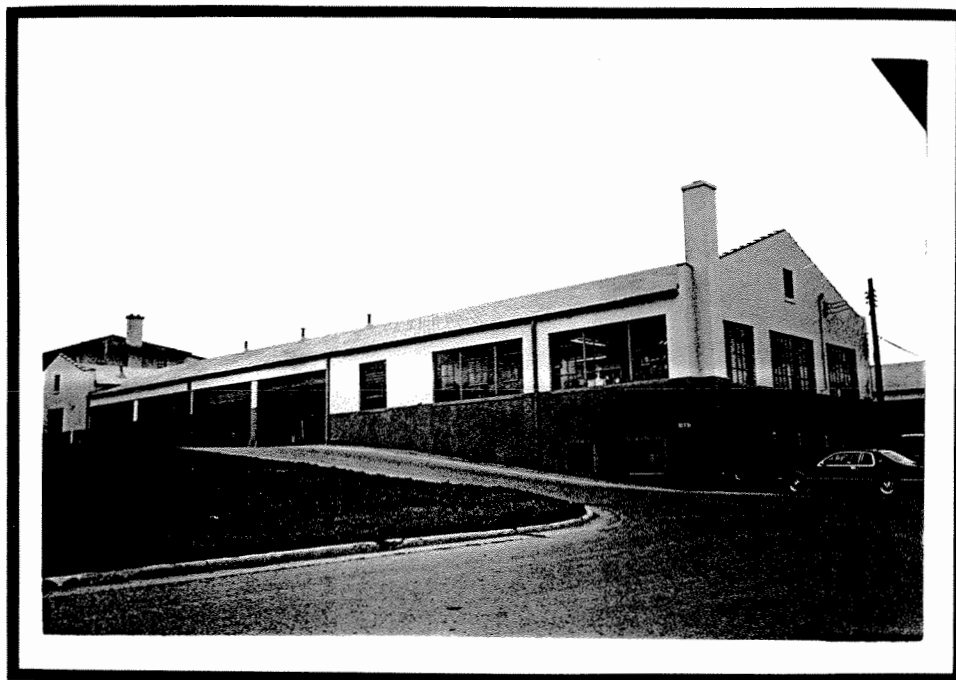
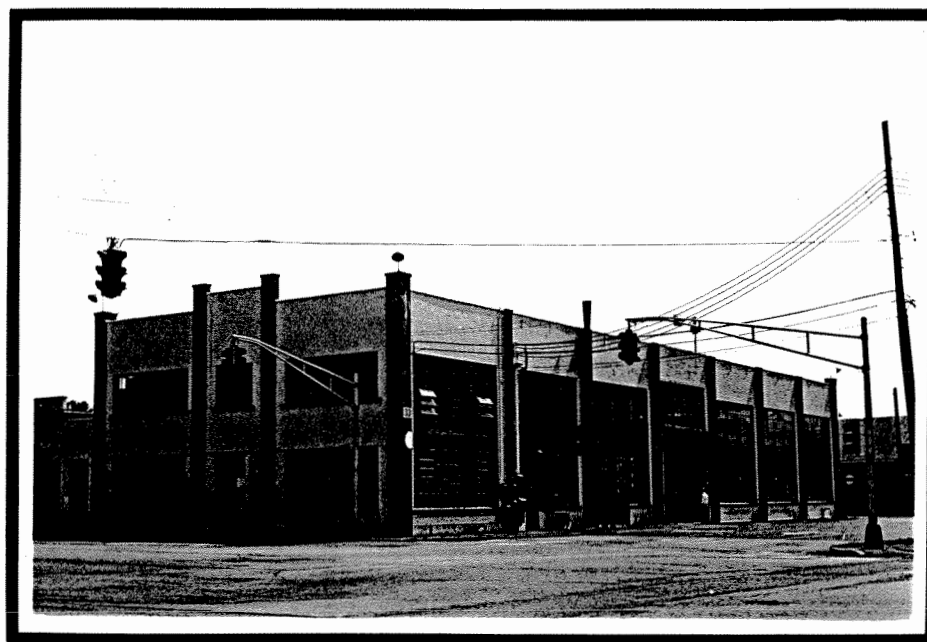
Figure III-177. 1934 Vehicle maintenance shop (Building 1501, Ft. Sill, Oklahoma), *above*. 1933 Vehicle repair shop (Building 33, Picatinny Arsenal, New Jersey), *below*.
